## **Inventory No. 35086 - George III Silver Microscope**

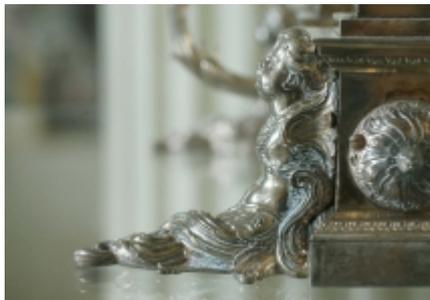
Fig. 1 Detail of the microscope on receipt.

number of accessories. The microscope had previously been cleaned, but unfortunately this was not done systematically and in a very poor fashion. From the amount of corrosion and cleaning fluid residues within the detailed decorative fittings, this was probably done using a water-based silver cleaning fluid which had not been thoroughly rinsed (if at all) nor quickly dried (Figs. 1 and 2).

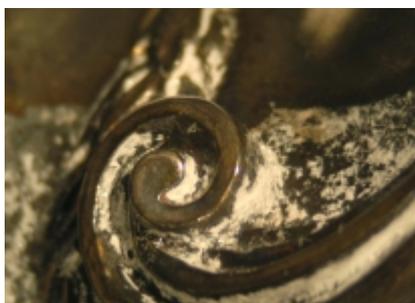
Fig. 3 Photomicrograph of cleaning product residues.

As a result of this the silver is tarnished very unevenly, ranging from yellow through to the violets and black, and there is a vast amount of cleaning fluid residues in the fine details of the silver (Figs. 3 and 4). The iron components are corroded, and, those components that are meant to move do not, due to build up of dirt and corrosion (in the case of iron components (Fig. 5)). There are a number of old damages to the object - small buckles and losses in the silver with some re-soldering, especially on the cherubs. There are quite a number of scratches on the silver particularly around the screws, and damage to the screw heads. Quite a number of screws are missing especially to the two figures that surmount the microscope. There is some damage to the knob of one of the cherub pillars; it is dented and has gauge marks in the silver. There are also some stress cracks in the silver.

Each piece of the silver microscope was then surface cleaned using Hagerty Silver Foam™ in a very controlled manner using cotton wool swabs and cocktail sticks. This was repeated as necessary to obtain good level of tarnish removal. Intricate areas had to be cleaned with a combination of very fine swabs and also just the end of the cocktail stick dipped in a little of the cleaning paste. Small areas were cleaned at any one time, and, after obtaining the desired degree of tarnish removal, the residues of the foaming silver polish were removed using de-ionised water on cotton wool swabs or on soft haired brushes, and then thoroughly dried with absorbent paper towelling. Each area was then allowed to air dry further for at least 24 hours before a protective layer of microcrystalline wax was applied. Iron alloy components were cleaned of corrosion using swabs of a fine grade steel wool rolled through a little of the microcrystalline wax to act as a lubricant or with a small brass bristle brush with the wax as a lubricant. This was repeated as necessary, until a satisfactory level of corrosion removal had been achieved. Any remaining residues were removed using clean, dry cotton wool swabs.

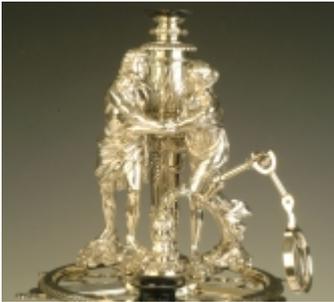
Fig. 6 Overall view after conservation.

When completed the microscope was re-assembled using the labels and photographic record as a guide (Figs. 6 - 8).

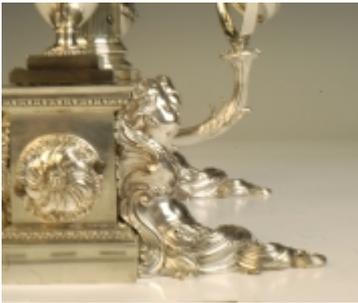
Fig. 7 Detail of figures after conservation.
